Nauti Nuf Time

1994 64' James Towner

Out- of- Water Condition and Valve Survey

December 13, 2007

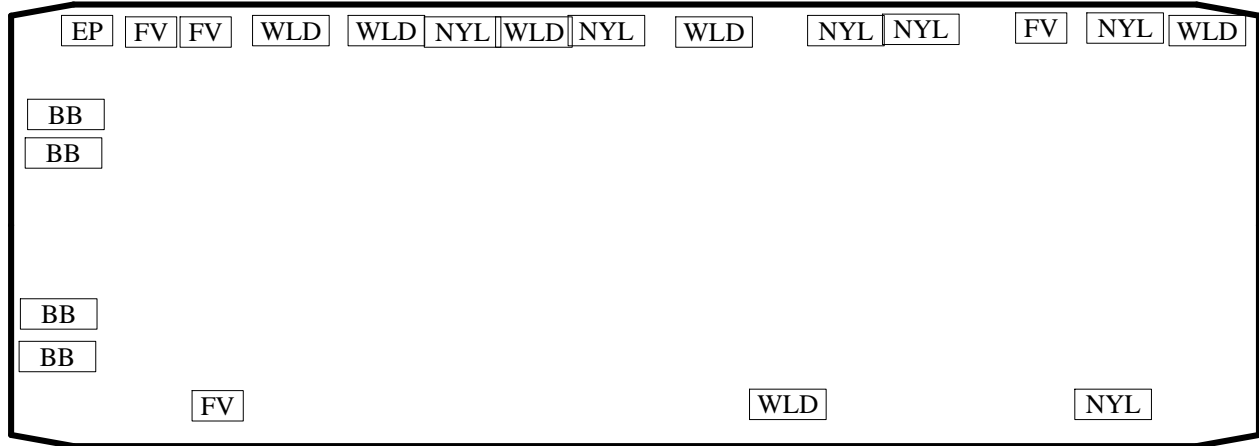
THRU-HULLS ABOVE WATER LINE (DIAGRAM):

NOTE: All above waterline thruhulls appeared serviceable.

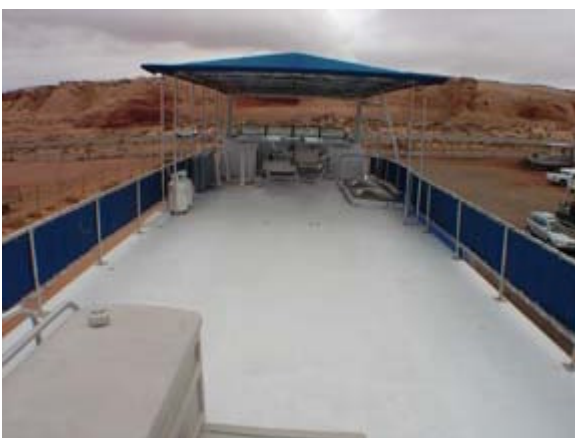
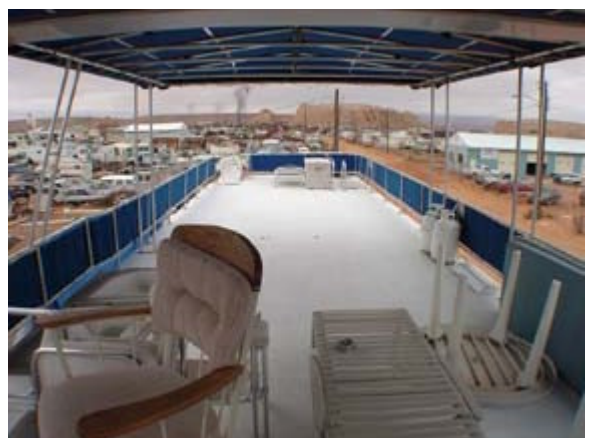
Upper deck, fore and aft

- * **SAFETY RAILS/GATES/CHAINS:** [C1] Tubular aluminum, appear to be in good condition. Loose fasteners noted on starboard side of upper deck.

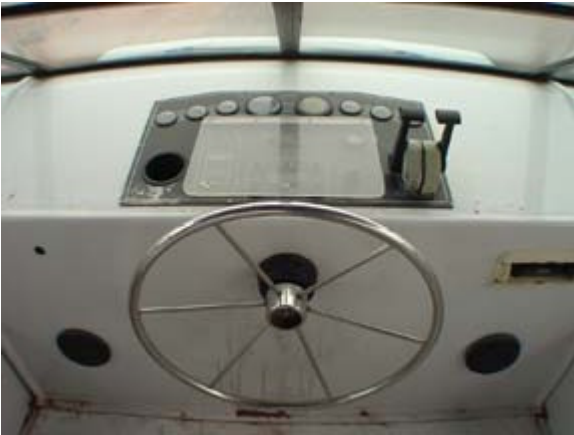
Flybridge and helm

- * **TYPE:** [C7] Hydraulic. The floor under the flybridge steering wheel has hydraulic oil stains.
- MANUFACTURER:** Morse at the flybridge and Teleflex / Sea Star 1.7 Helm HH2571.
- NUMBER OF STATIONS:** Two, lower helm and flybridge.

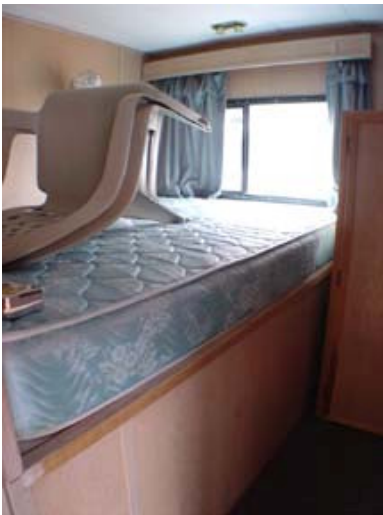
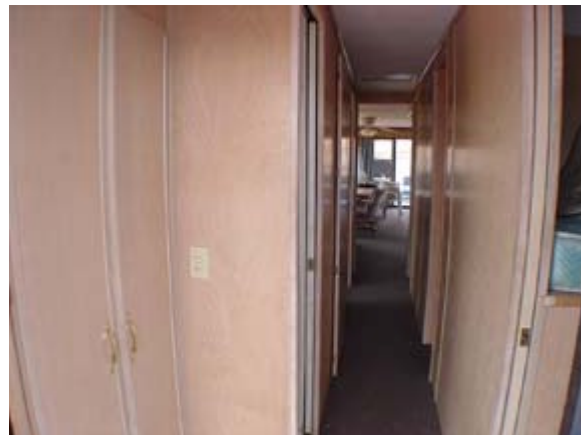
Aft guest berth and hallway

- * **WATER INTRUSION SIGNS:** [C3] Water intrusion sighted in the forward head, aft guest berth, and under most all windows.

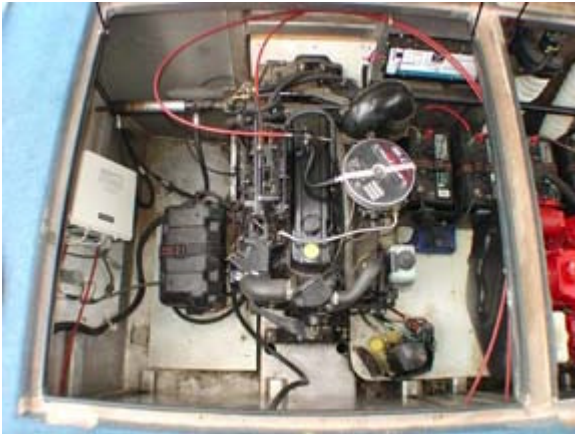
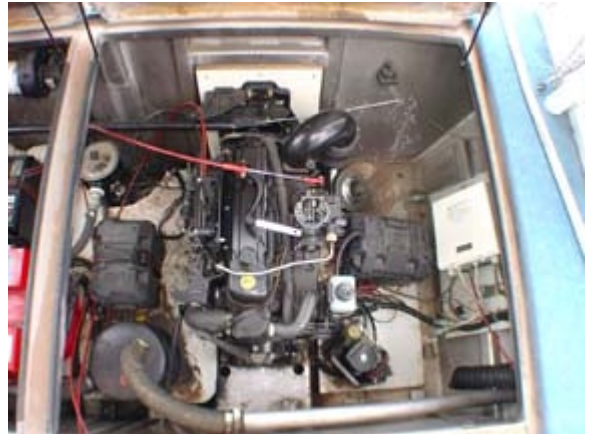
Engines, starboard and port

* **TYPE:** [C5] Twin I/Os. Engine hatch shocks appear to be weakening. Engine hatches do not have safety ropes.

- All hinged hatches shall have a means or method to keep the hatch in an open position (ABYC H-3.4.11). Recommend installation of a safety rope on each hatch so it can be secured open in adverse conditions. Recommend replacing weak shocks.*
